THE FEASIBILITY OF BURNER-CAN BURN-
THROUGH THERMAL DETECTION PRIOR TO
ENGINE CASE RUPTURE

14
Report No. **FAA-RD-72-134**

Richard Hill
National Aviation Facilities Experimental Center
Atlantic City, New Jersey 08405

FINAL REPORT

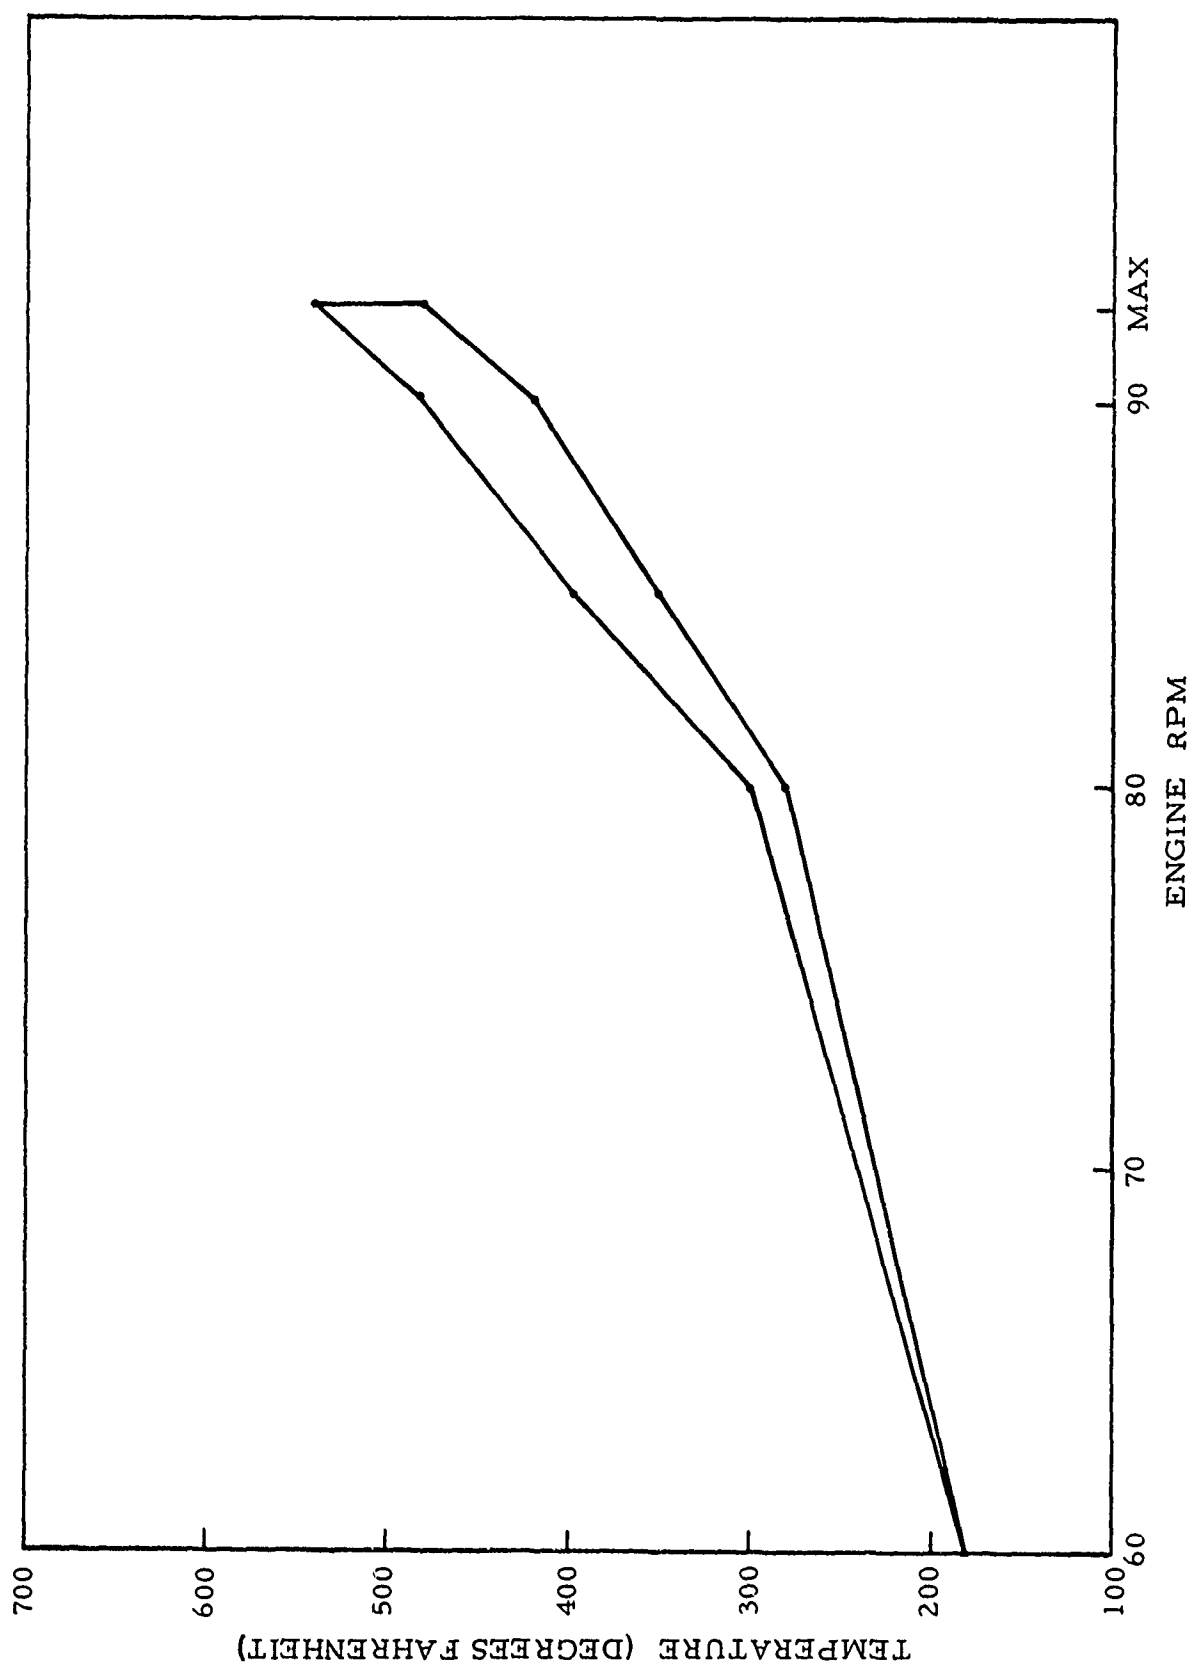
FIGURE 29. J57 ENGINE DIFFUSER CASE TEMPERATURE RANGE

The results of the background test are shown in Figures 29 and 30. The two lines on each graph represent the highest and lowest temperatures measured on the diffuser case (Figure 29) and burner can case (Figure 30) at various locations 360° around the engine.
